111-50-10750-2037**CORRECTION****Water body name:****Survey date:** 10/1/2013**Water body number:** 111-50-10750-2037**Species & Lifestage:** CO, DVr, CTr**Watershed:** Admiralty Island-Frontal Lynn Canal**MTR:** C041S066E **Quad:** Juneau B-2

Table 1.—111-50-10750-2037 survey data.

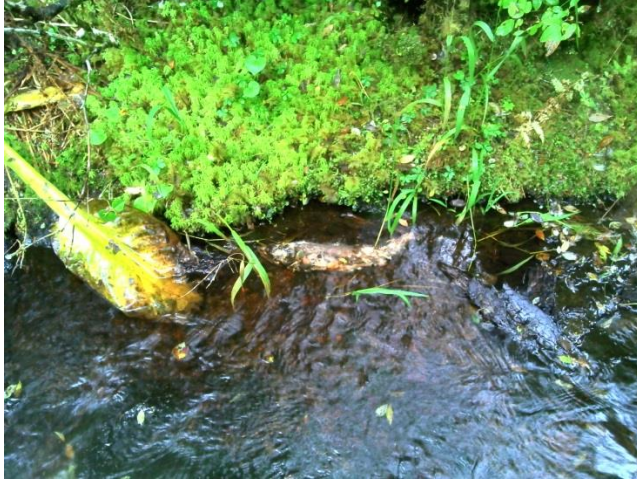
Figure 1.–Pink salmon carcass.

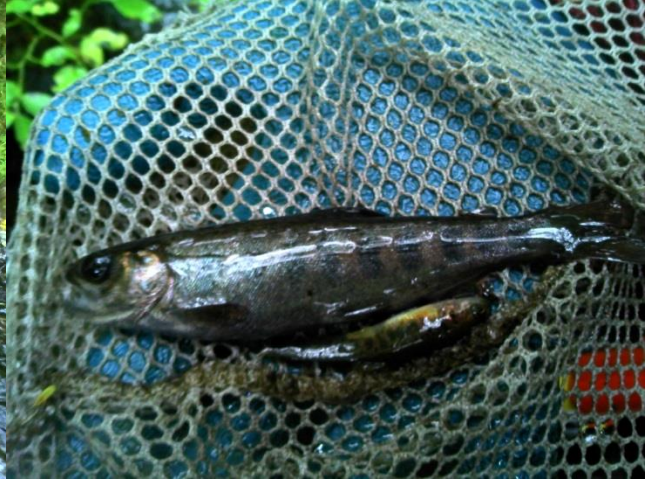
Figure 2.–Captured rearing coho salmon.

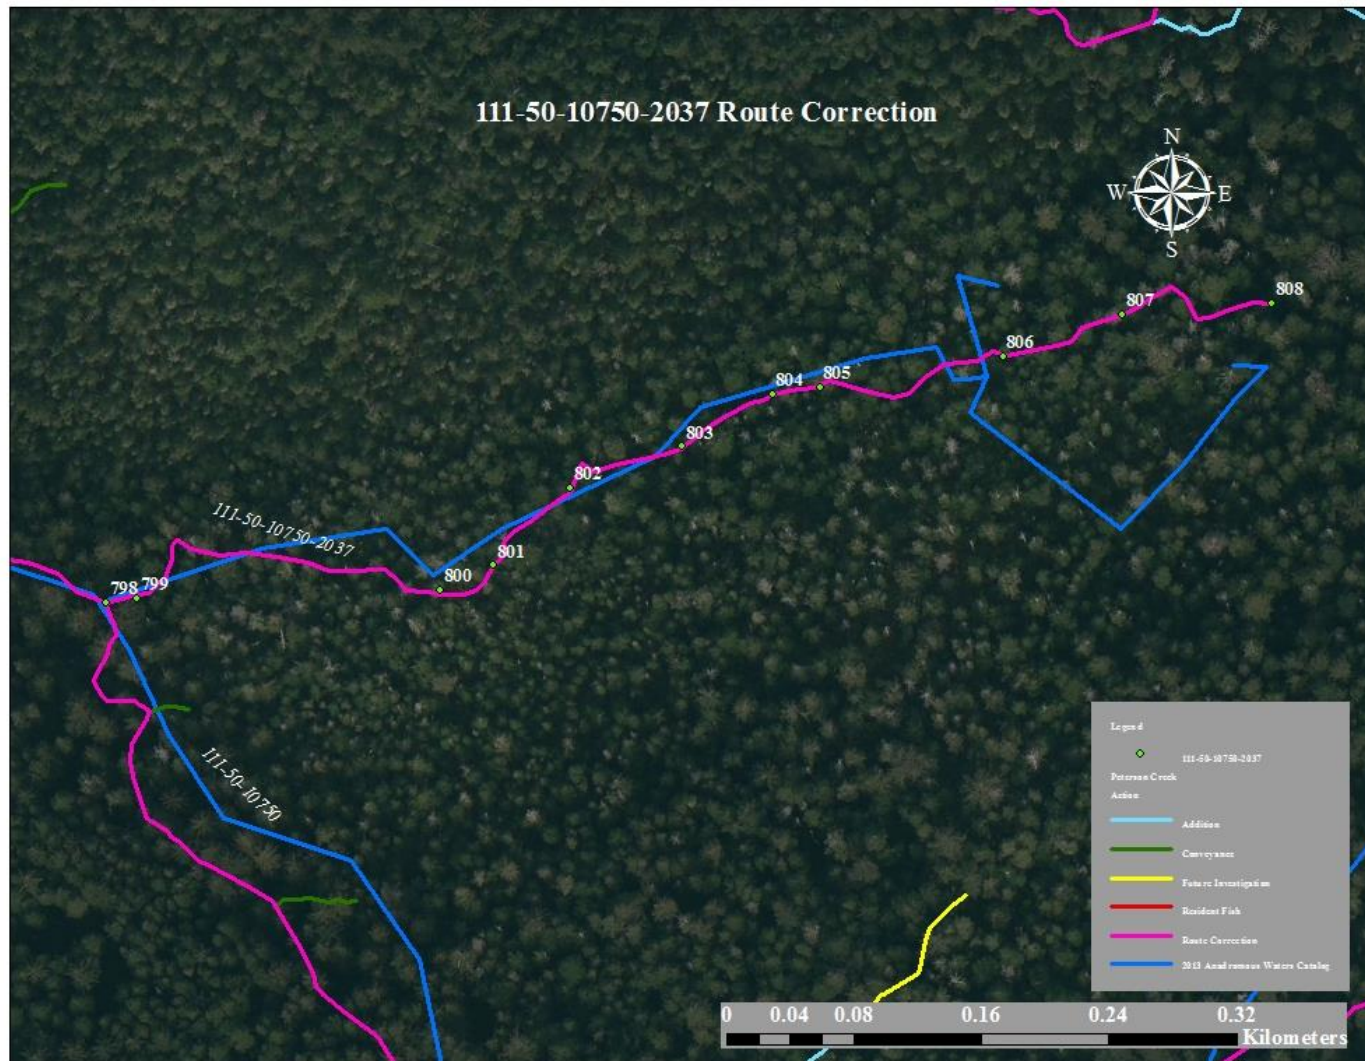
Figure 3.–111-50-10750-2037 route correction map.

Recommendations: Correct the current course in AWC.
